NBSIR 74-467

Simulated Solar Heat Tests on M.U.S.T. Air-Inflatable, Double-Wall Hospital Ward Shelters

Final Report

Prepared for
United States Army Natick Laboratories
Shelters Branch
Natick, Massachusetts 01760

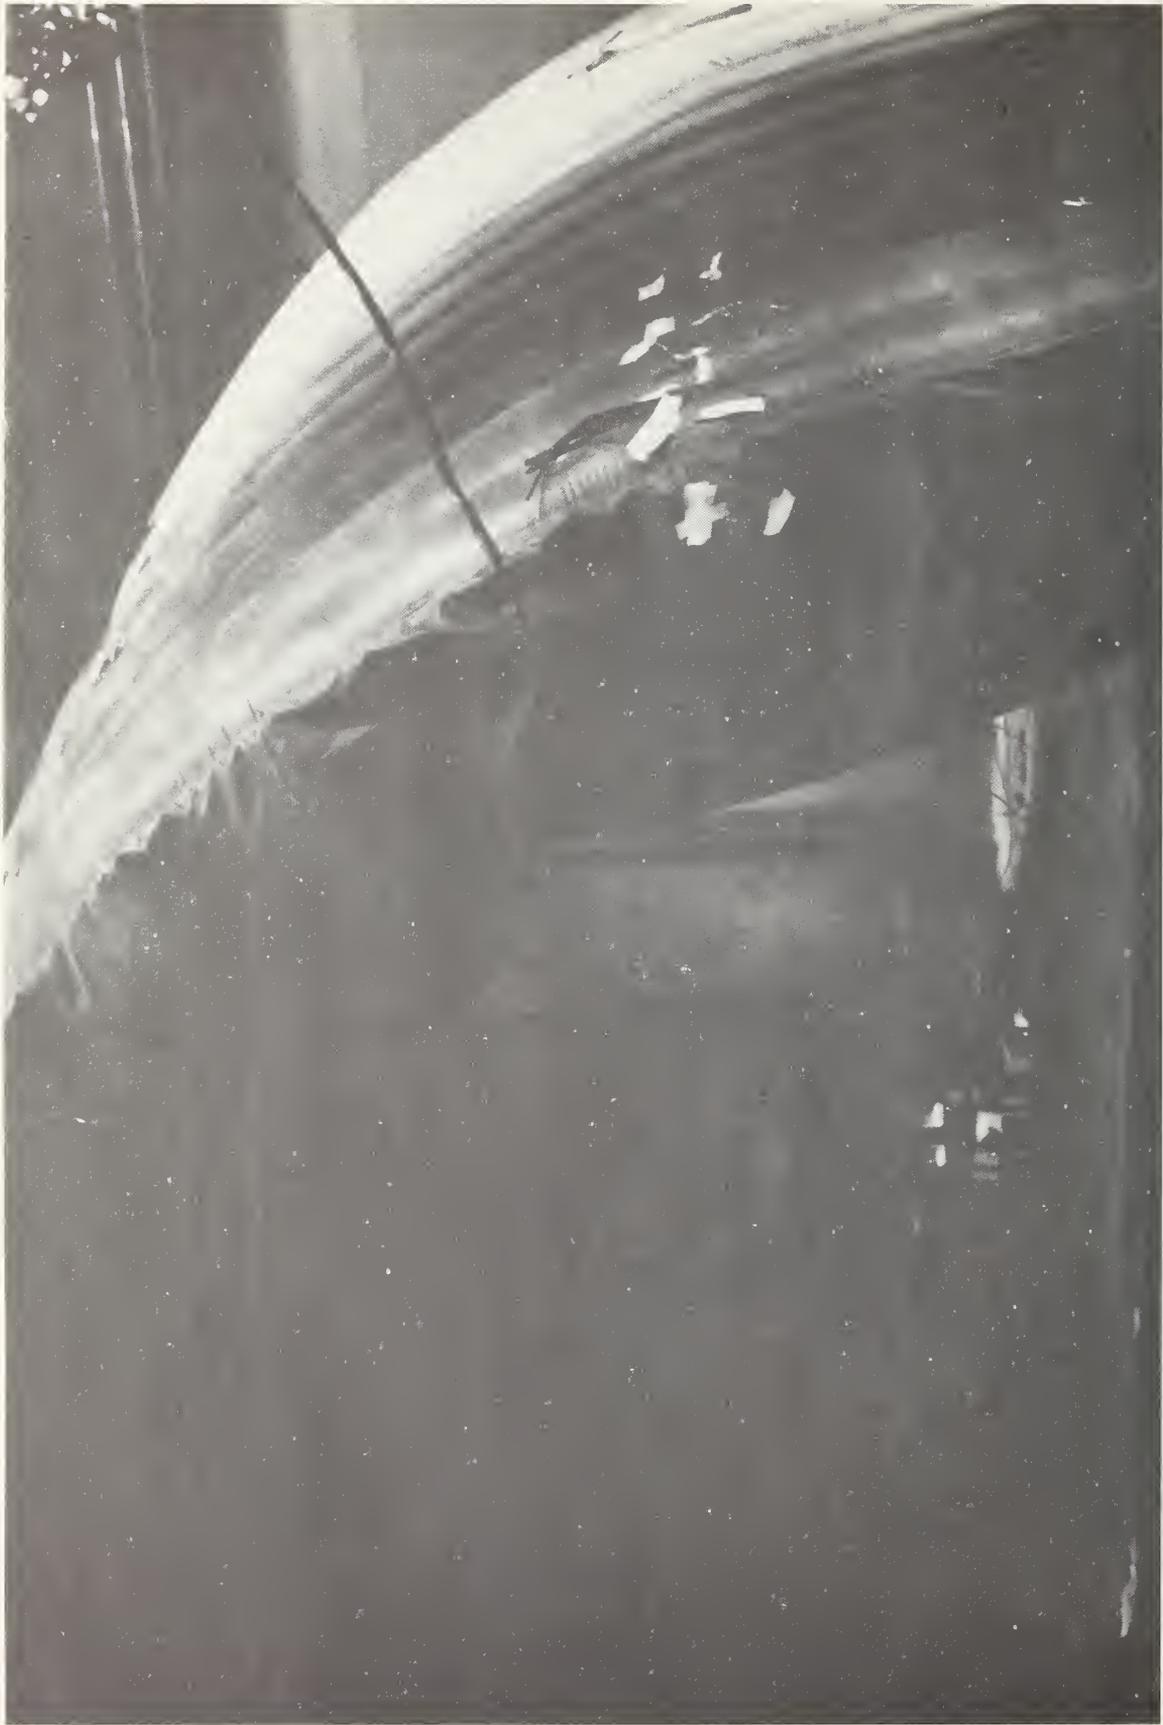
The bladder in air chamber 1 ruptured about 2 hours after commencing the first test cycle. Figure 10 shows the erected shelter section following the deflation of bladder 1. The bladder in air chamber 10 lost air rapidly due to leakage during the first test cycle. At the completion of the first test cycle, the bladders in air chambers 1 and 10 were removed for inspection. Bladder 1 had ruptured at an adhesive bond. The fabric on either side of the rupture was well bonded. The failure is shown in figures 11 and 12. The rupture was about 7 in. in length. Bladder 10 was leak tested and the only observable leak was near the air inlet valve. The bladders which were removed from air chambers 1 and 10 were replaced by the bladders from air chambers 6 and 5 respectively of shelter section F-1 prior to conducting the second test cycle.

Figure 10. Erected Shelter Section F-2
Following the Deflation of the
Bladder in Air Chamber 1.

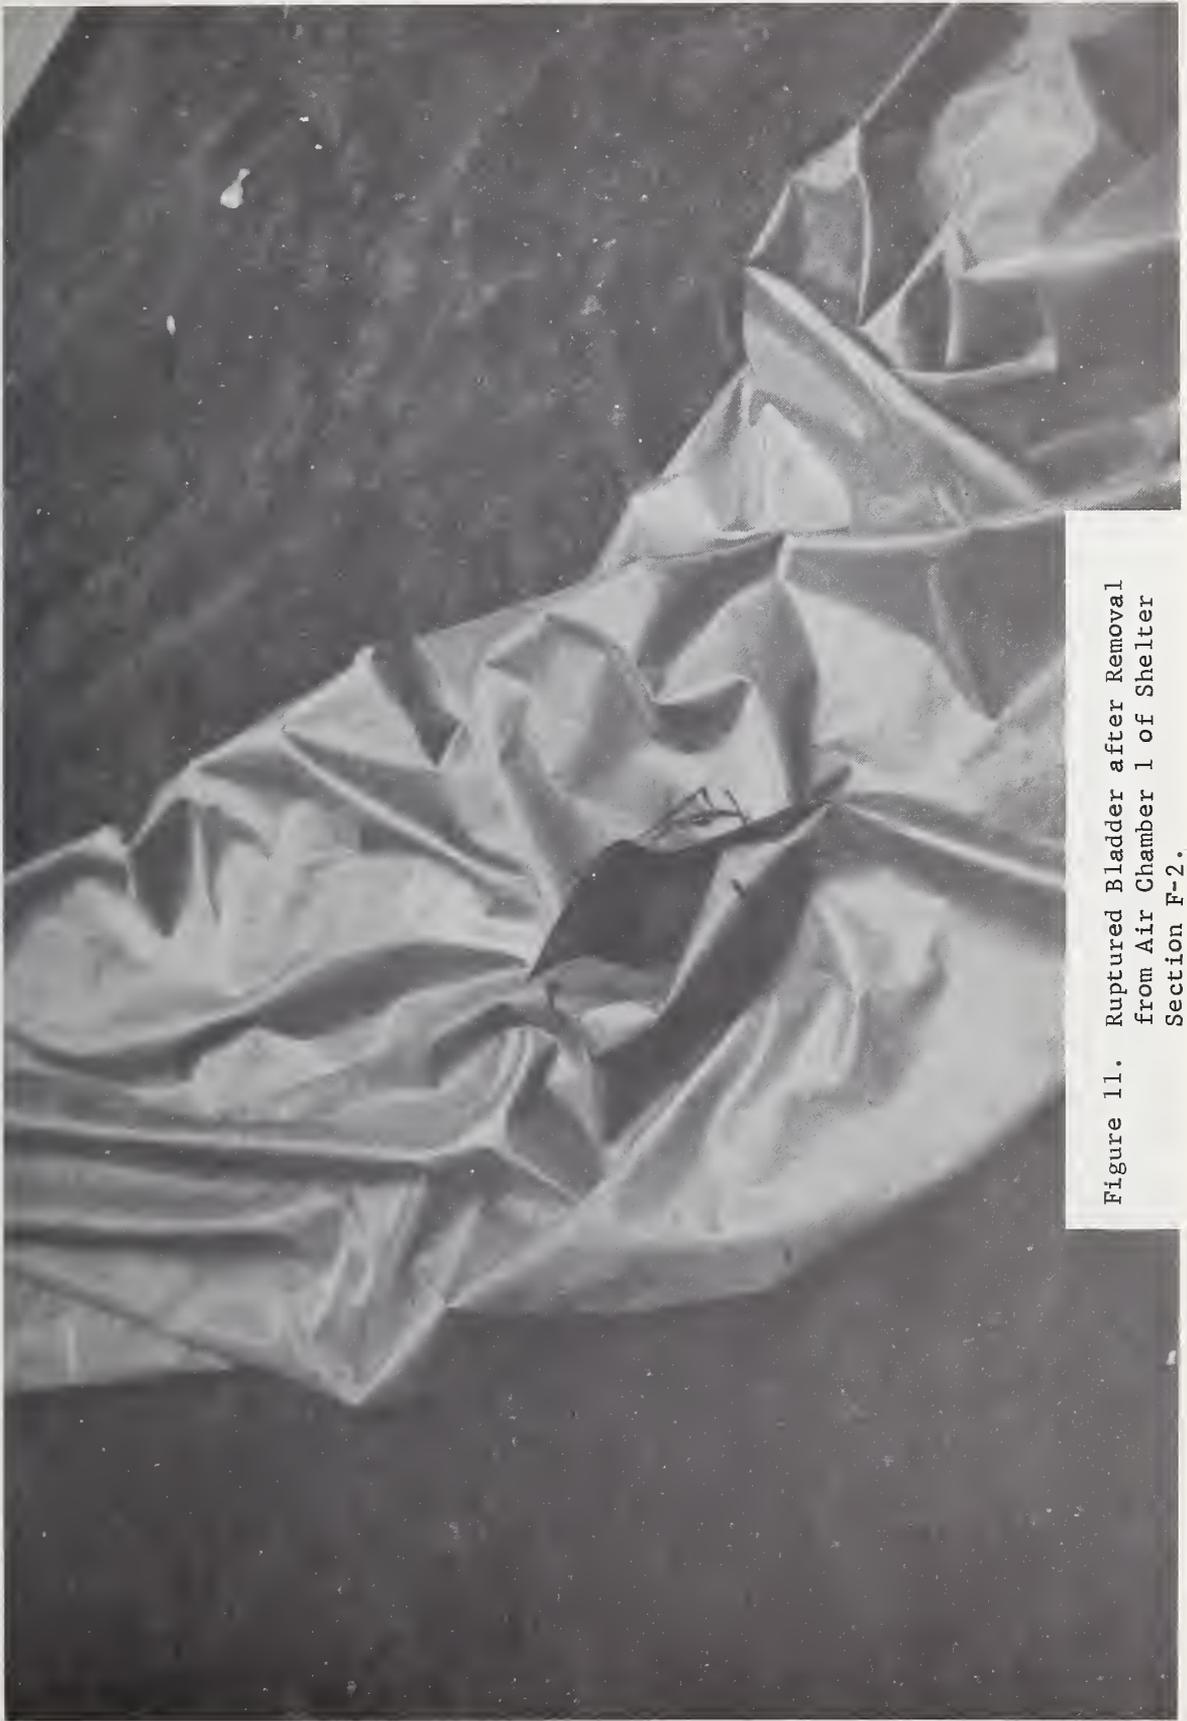
A. The bladder in air chamber 1 of shelter section F-2 ruptured during the first solar heat load cycle due to an adhesive bond failure between the bonded fabric.

Figure 11. Ruptured Bladder after Removal
from Air Chamber 1 of Shelter
Section F-2.

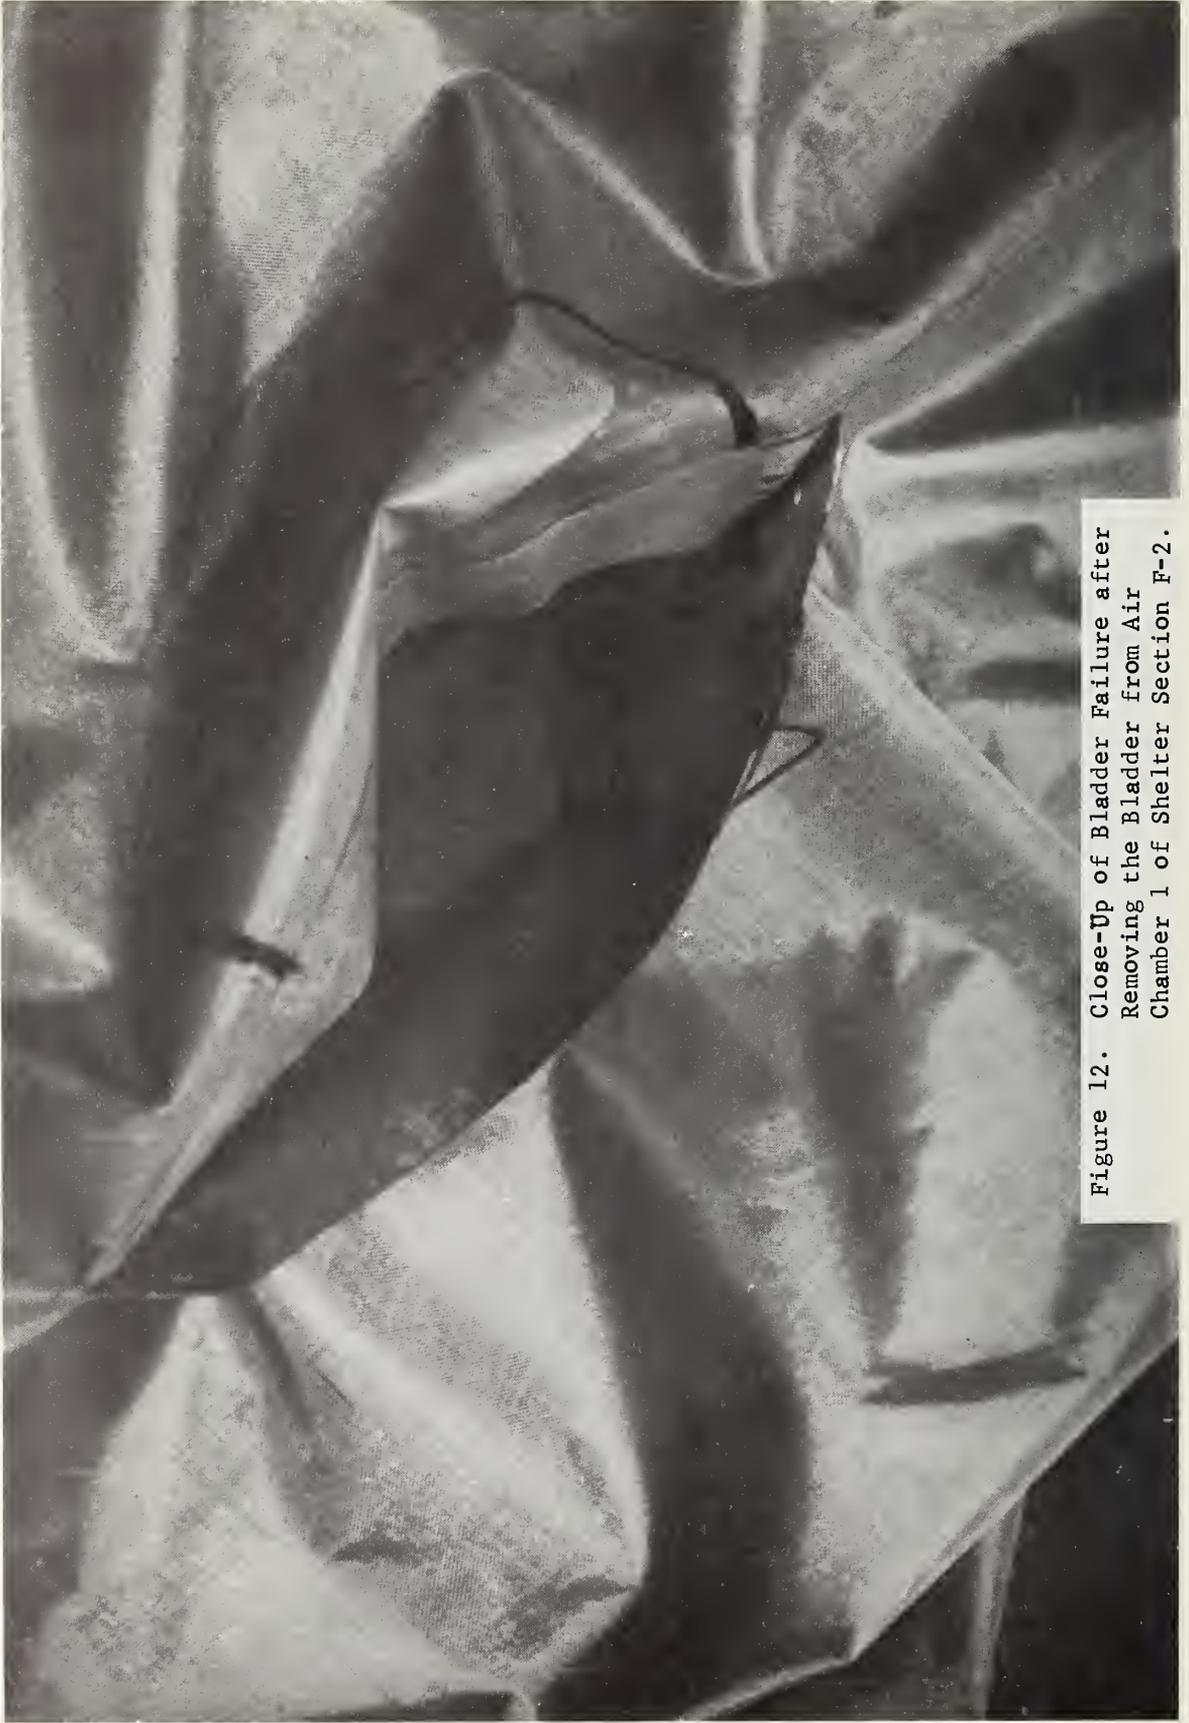
Figure 12. Close-Up of Bladder Failure after
Removing the Bladder from Air
Chamber 1 of Shelter Section F-2.

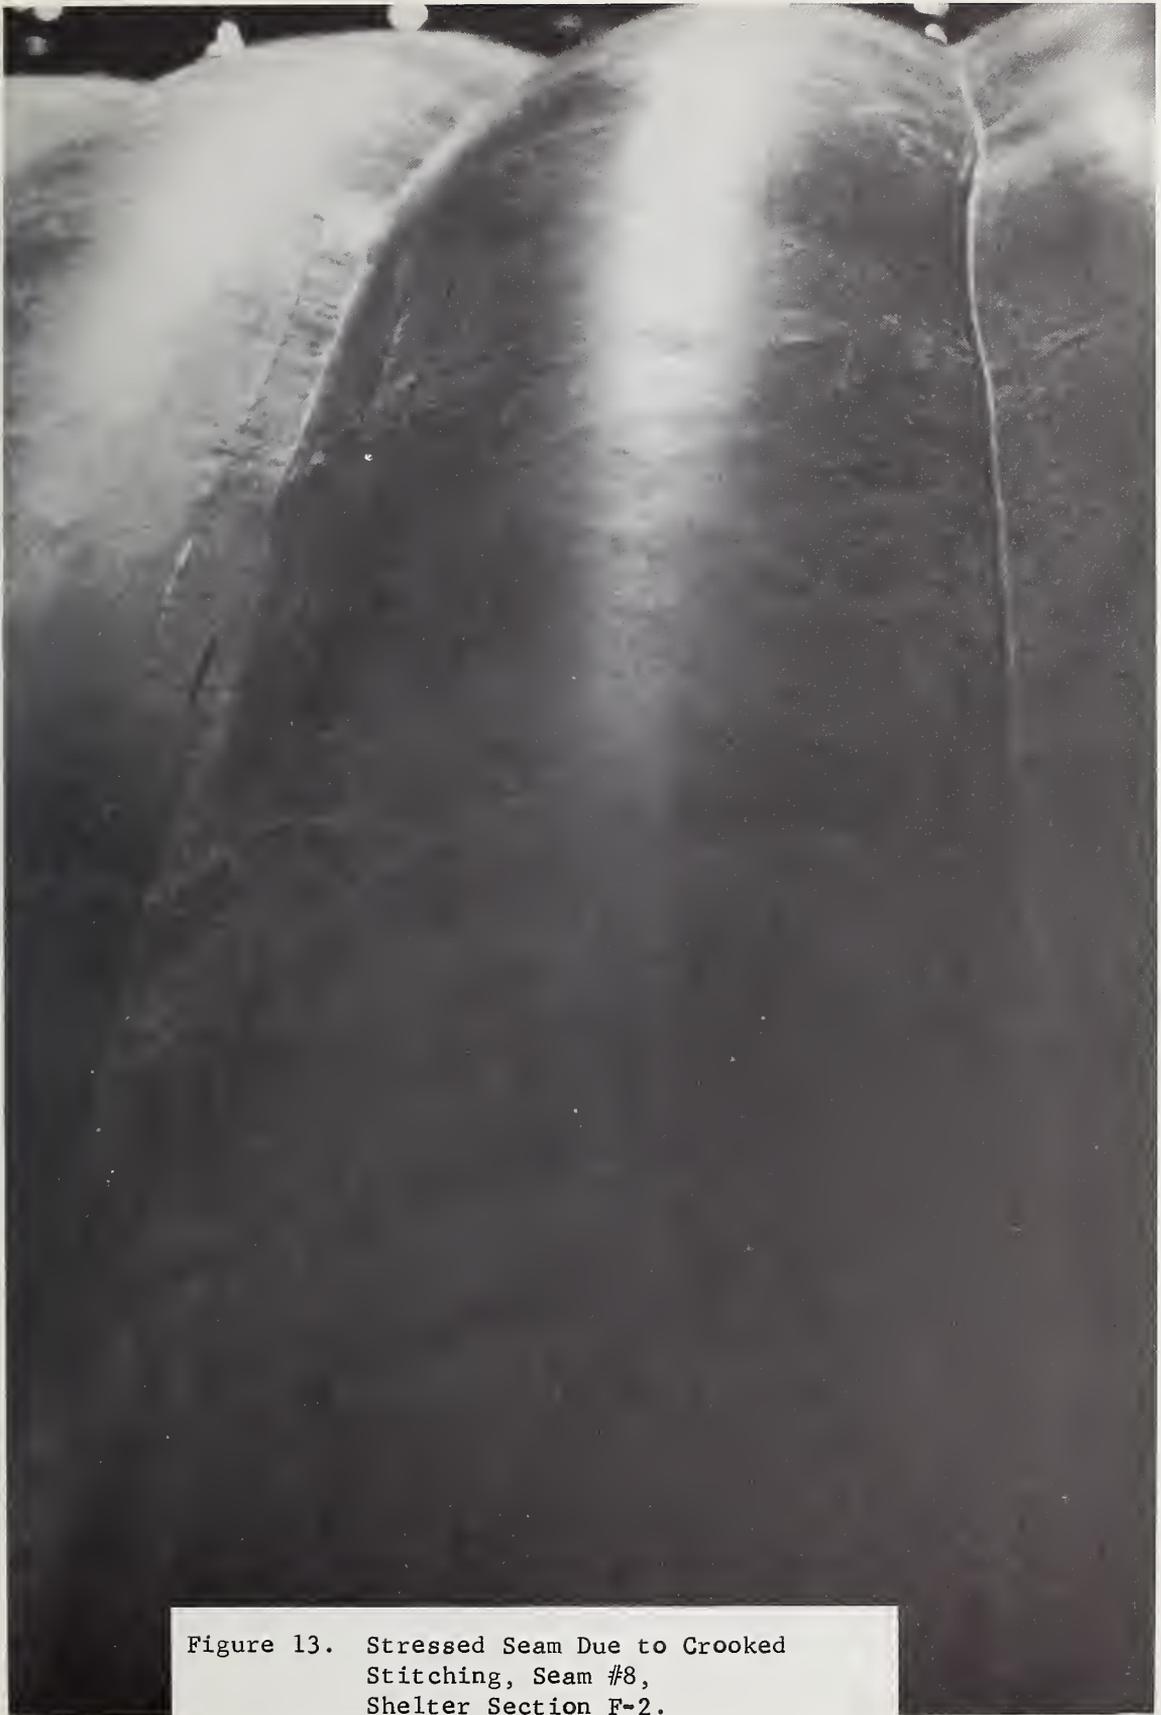
D. Strapping failures could often be related to excessive wrinkling of the exterior fabric near the sewn seams or excessive stress developed at the seam due to crooked seams.

Figure 13. Stressed Seam Due to Crooked
Stitching, Seam #8,
Shelter Section F-2.

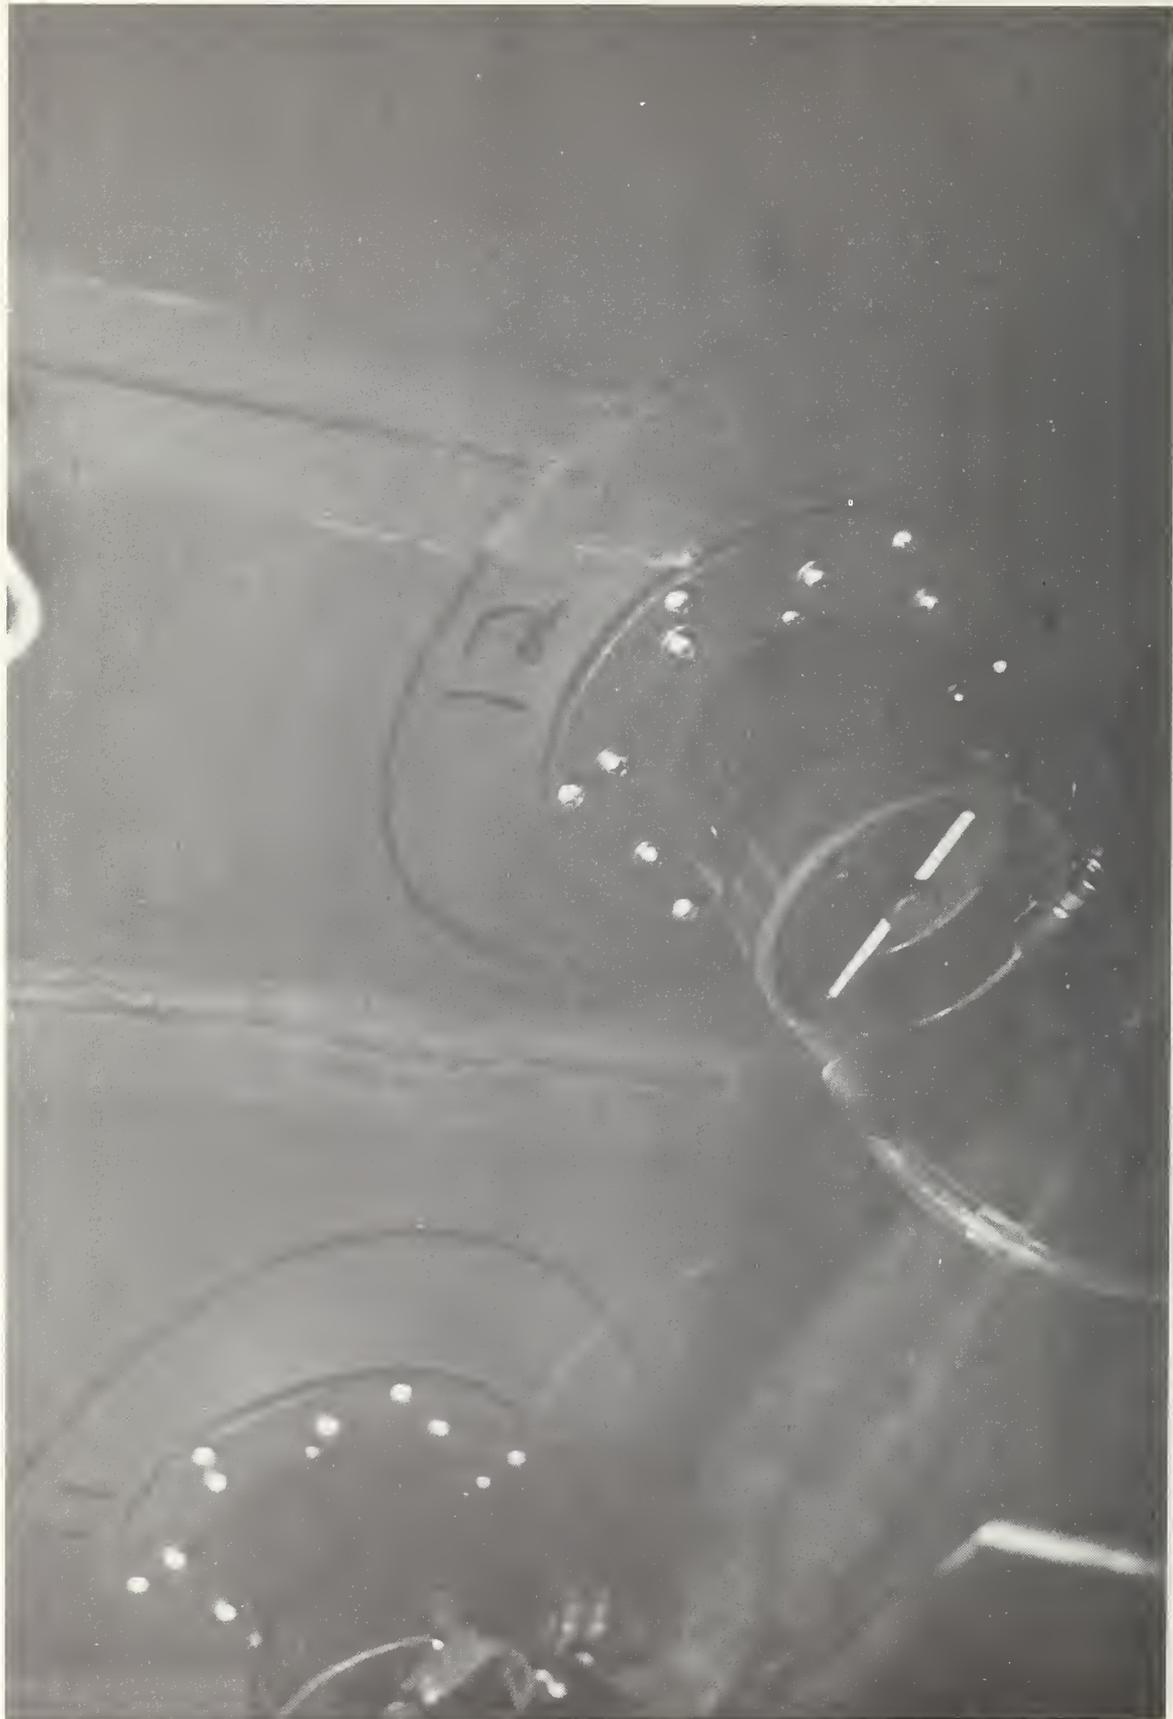
The fabric comprising the air inlet valve ring collar was observed to pull or slip slightly from the original location on all 12 air chambers. This fabric slippage was primarily on the sides rather than at the top and bottom. The slippage on the collar of air chamber 12 was about 3/32" while other slippages ranged from 1/13" to 1/18". Figure 14 shows the fabric slippage for the collars of air chambers 11 and 12. The picture in figure 14 was taken following the second test cycle but most of the slippage occurred during the first test cycle.

B. The air inlet valve ring collars on all 12 air chambers of shelter section F-2 were observed to slip somewhat during the solar heat load tests and slight delaminations of the ring collars were observed on air chambers 7 through 12.

Figure 14. Air Inlet Valve Ring Collar
Slippage on Air Chambers 11 and
12 of Shelter Section F-2.

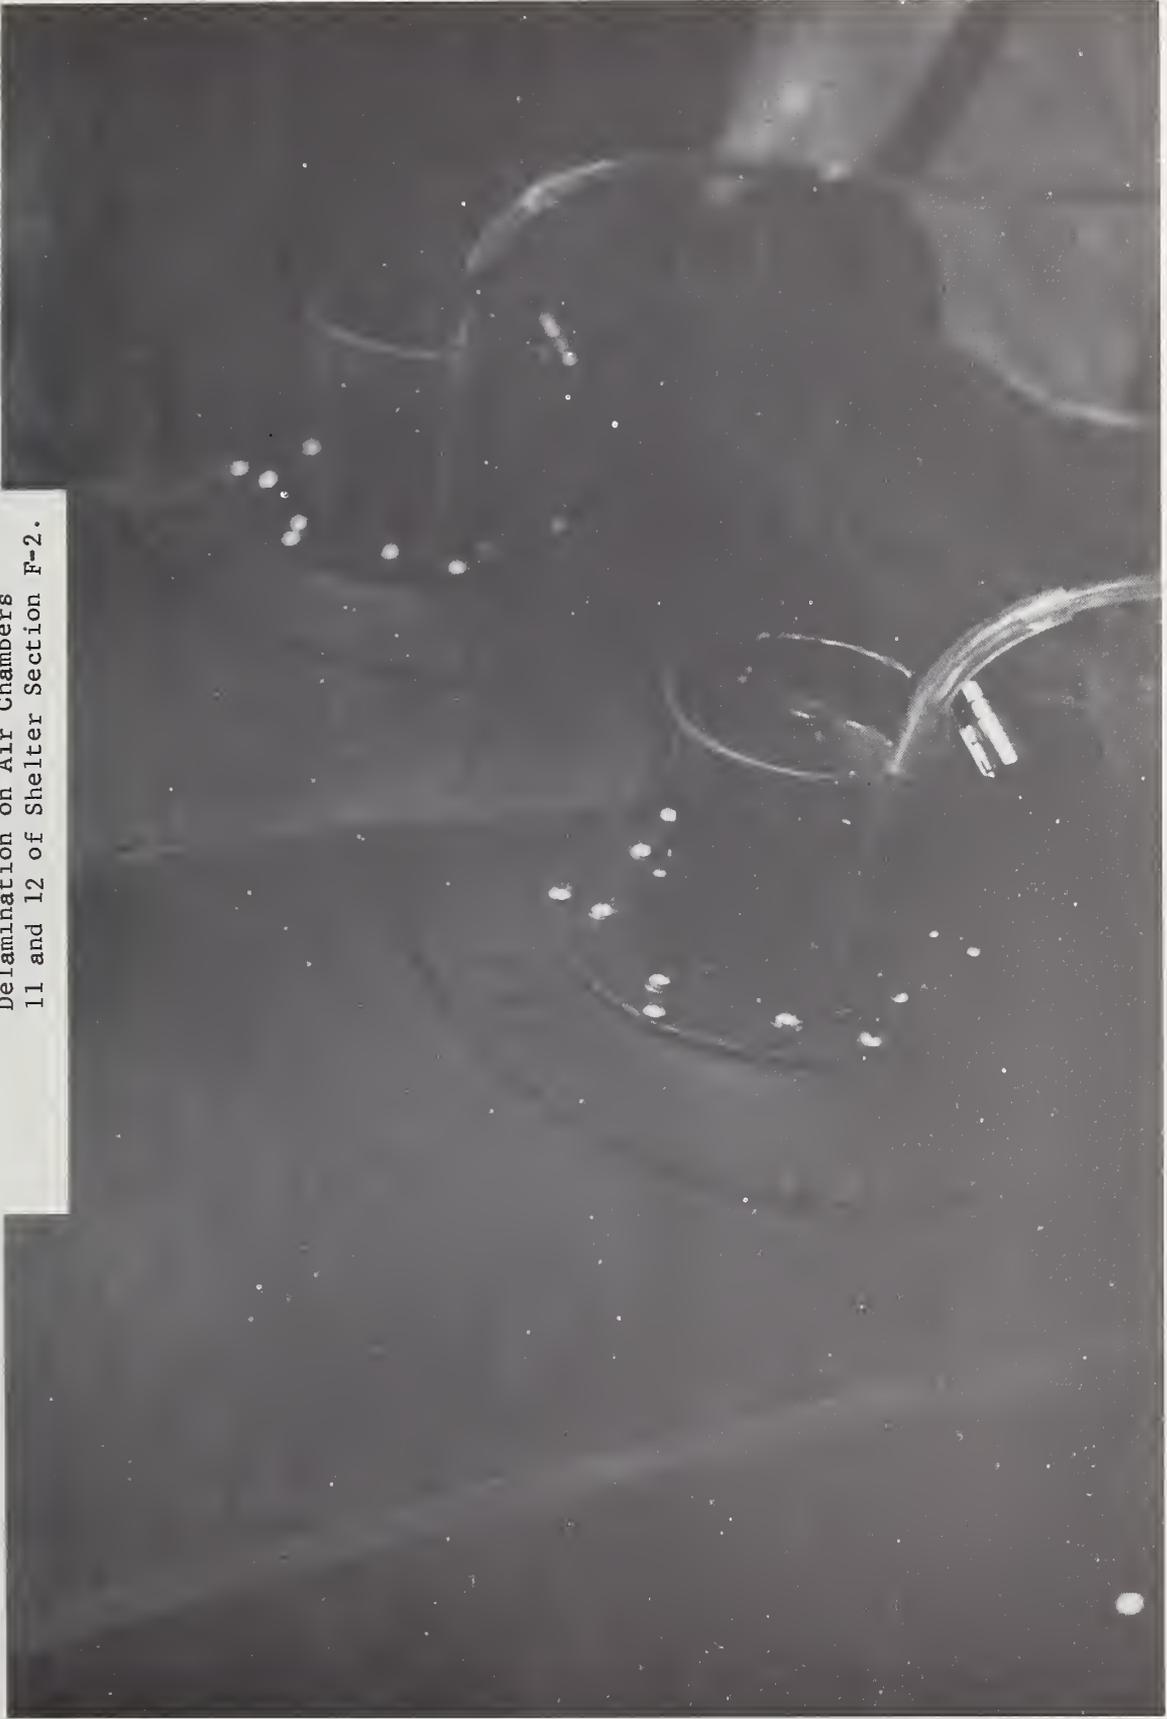
Slight delaminations of some valve ring collars were also observed at the completion of the first test cycle. The delaminations were noted on the collars of air chambers 7, 8, 9, 10, 11 and 12. Figure 15 contains a picture of the delaminations at air chambers 11 and 12. The delaminations were not greater than 1/2" in width and 1" in depth and they did not extend farther during the second test cycle. One screw hole in the collar of air chamber 2 also pulled out during the first test cycle. The movement was about 1/2".

Figure 15. Air Inlet Valve Ring Collar
Delamination on Air Chambers
11 and 12 of Shelter Section F-2.

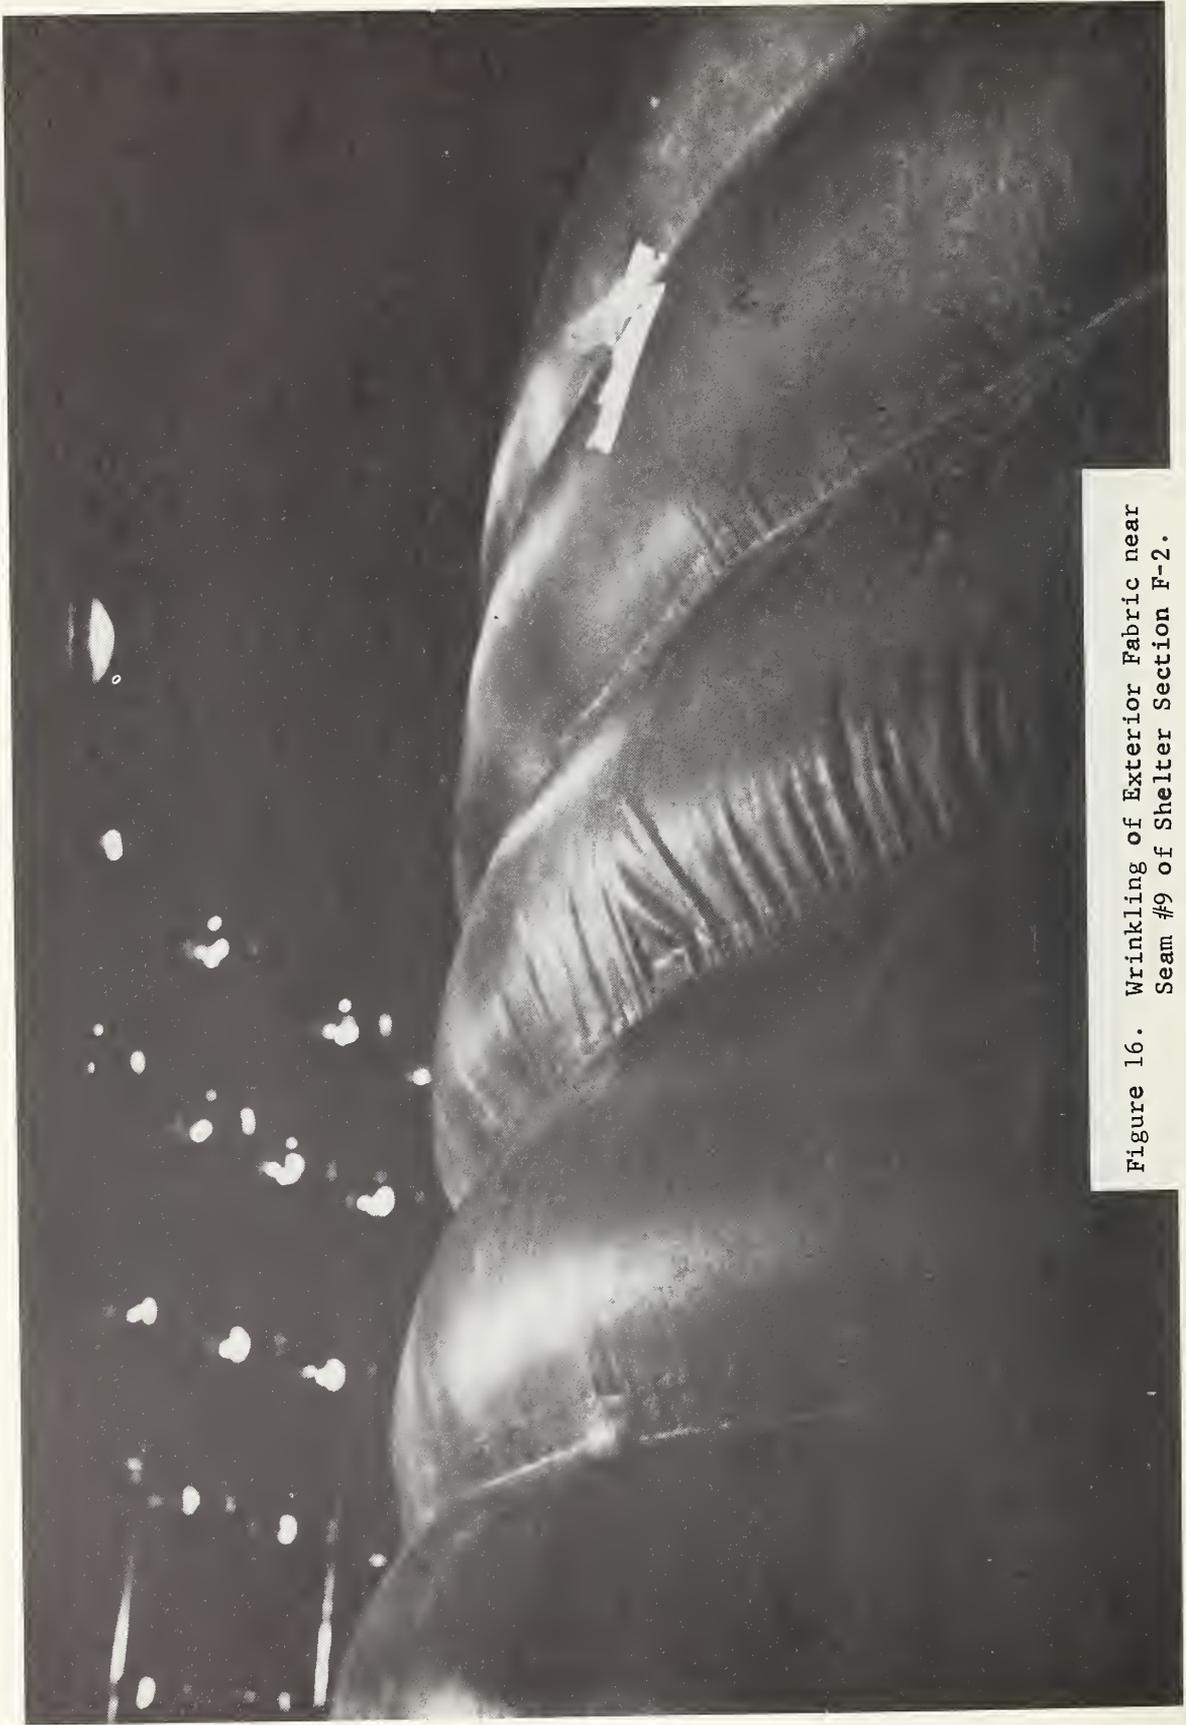
One additional observation was that occasionally the exterior fabric near a sewn seam was wrinkled as shown in figure 16 for seam 9. The wrinkling leads to difficulty in bonding the strapping and edge lifts and tunneling were commonly observed at these locations.

Figure 16. Wrinkling of Exterior Fabric near Seam #9 of Shelter Section F-2.

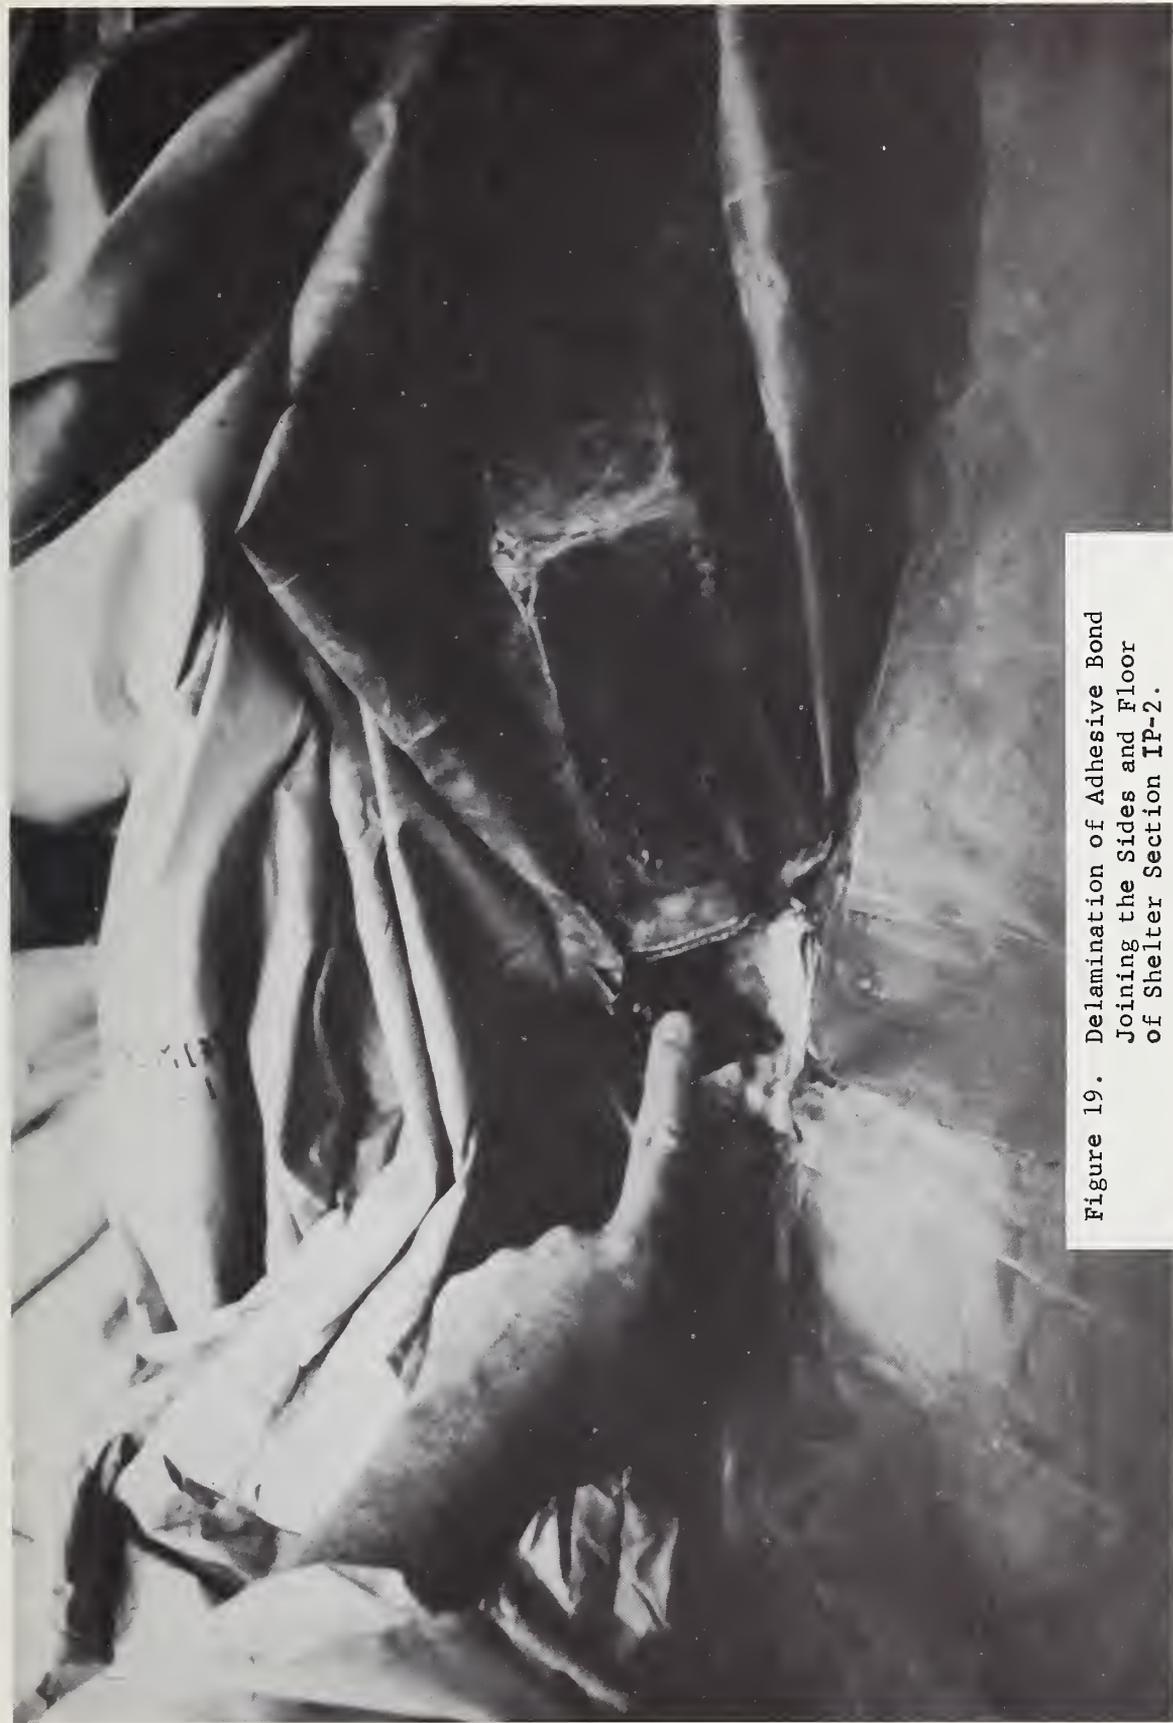
D. The adhesive bond between the valve side and the floor of shelter section IP-2 failed directly below air chamber 1 during the solar heat load test.

Figure 19. Delamination of Adhesive Bond
Joining the Sides and Floor
of Shelter Section IP-2.

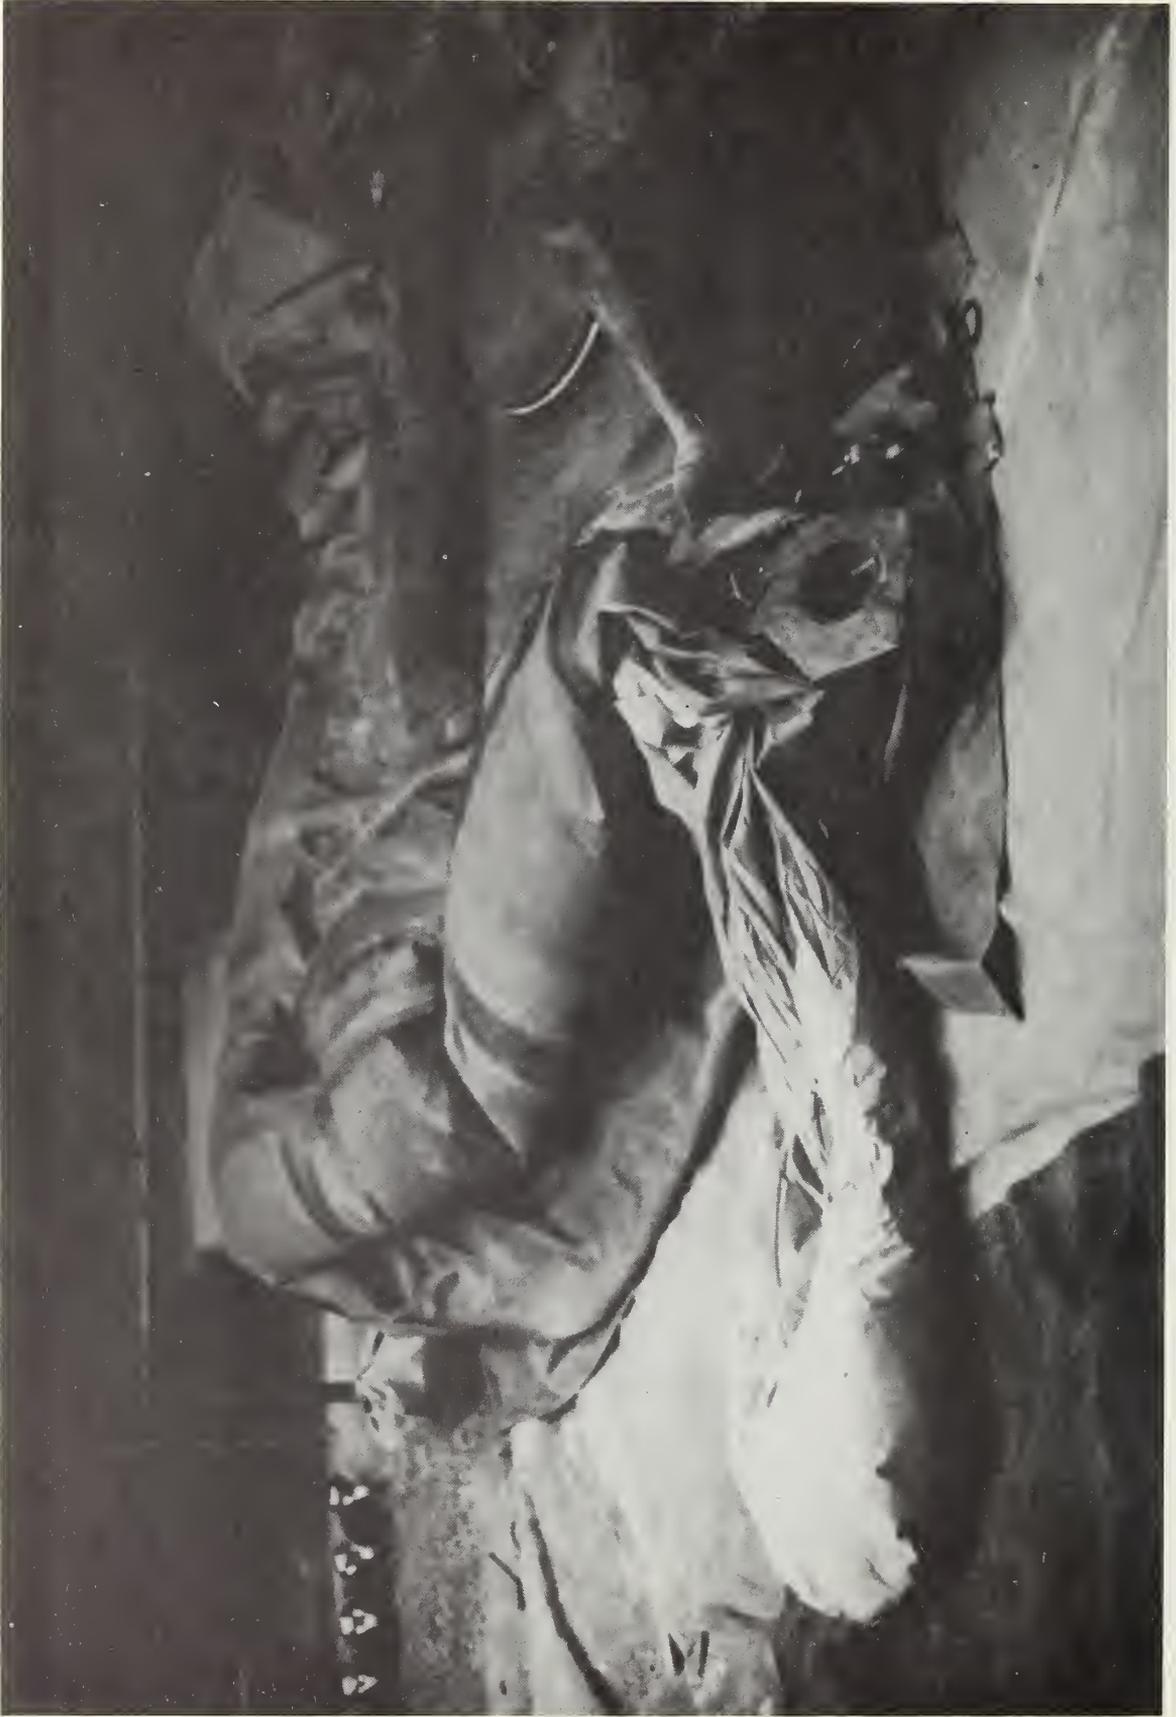
Figure 20. Excess Bladder Pulled from Air Chamber 1 of Shelter Section IP-2.
